## Faceting Machine Alignment

## Faceting Machine Alignment by Paul A. Head, Old Pueblo Lapidary Club Faceting Guild

Originally presented in the United States Faceters Guild Newsletter

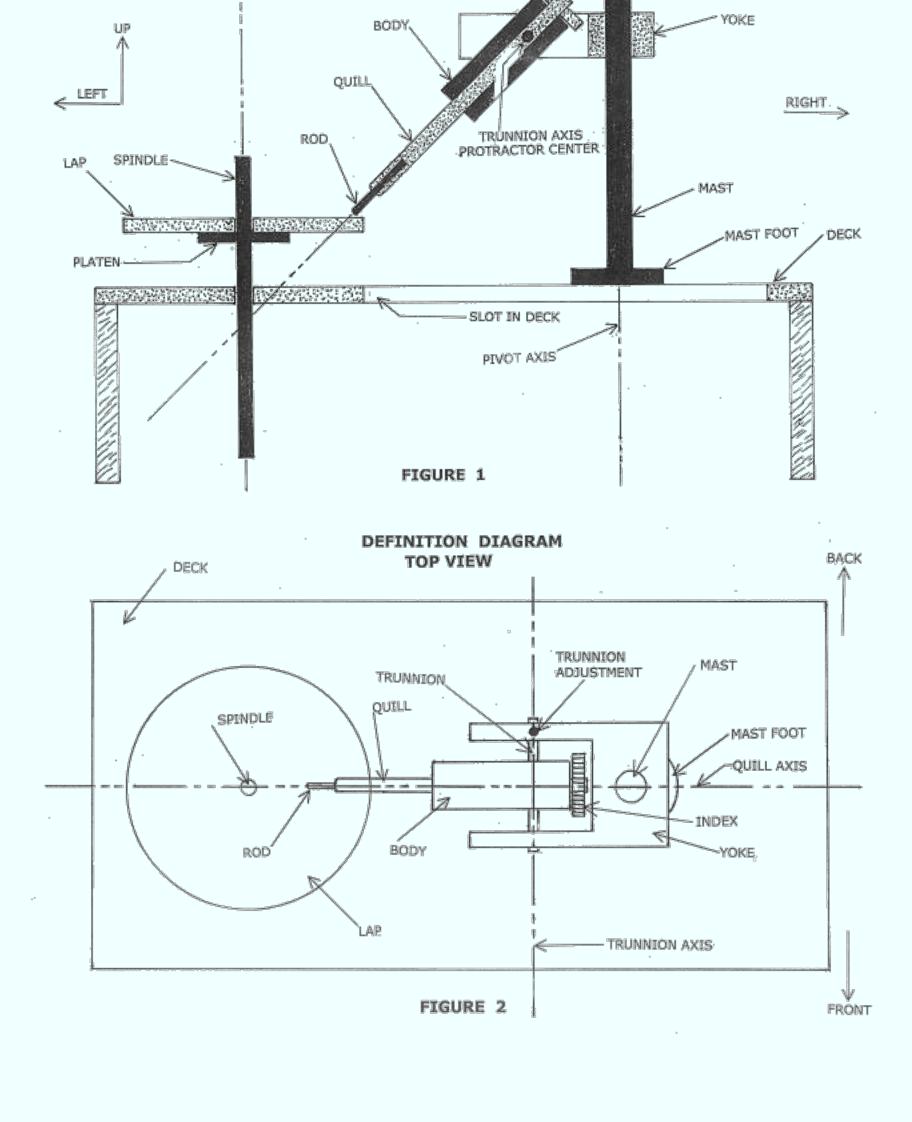
**DEFINITION DIAGRAM** FRONT VIEW

maintenance schedule using this procedure takes only about 15 minutes unless serious problems are encountered. Although a generic mast style machine is discussed the basic ideas will generally apply to other types as well. The essential elements of such a machine are depicted on Figures 1 and 2, or

defined in the following list. These basic machine elements have been capitalized for the rest of this text. **DEFINITIONS:**

QUILL AXIS SPINDLE AXIS
